RISK ASSESSMENT™

Commercial Investor

Commercial Investor
Santa Barbara, CA.

RISK ASSESSMENT

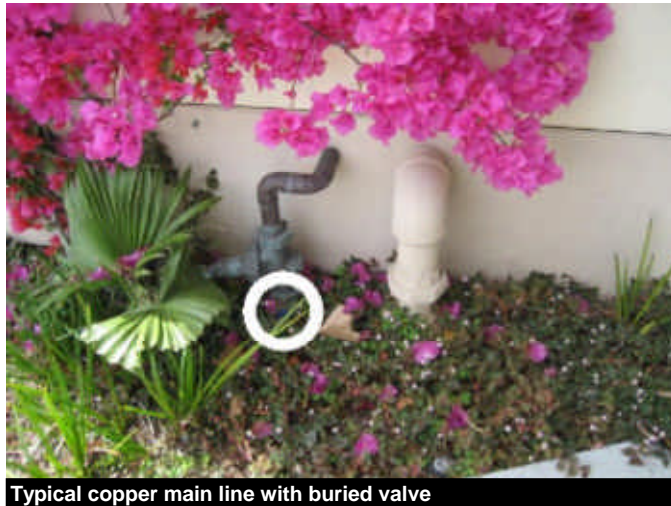
Typical copper main line with buried valve

Needs Attention, many of the main shut off valves are at least partially blocked.

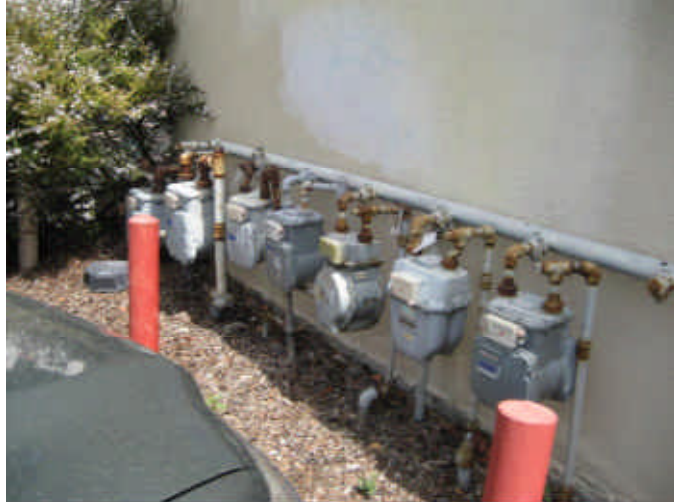
All the meters are located on the right side of the rear building in the parking lot.

It is advised to have the gas provider inspect the gas system to determine its condition and check all the gas appliances and fixtures. This is usually a free service.

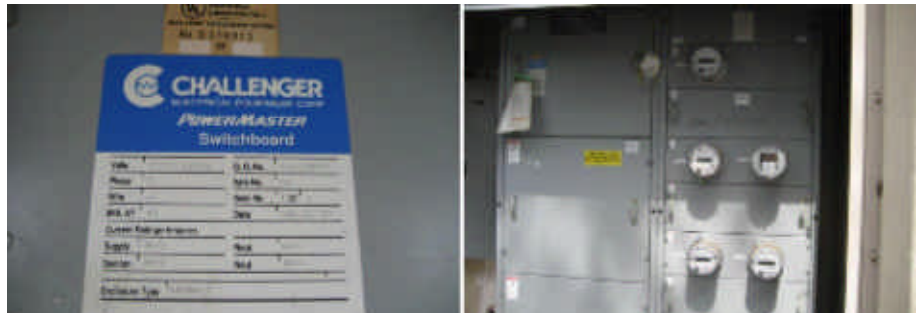
Right building main panel.

Service Amperage - 800 amp Stand up panel in the right building.

MAIN PANEL CONDITION: Serviceable for both buildings.

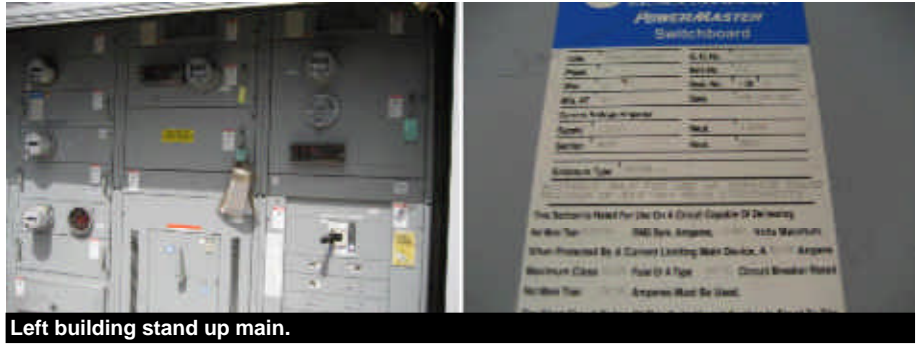
The left building has a 1200 amp stand up panel.

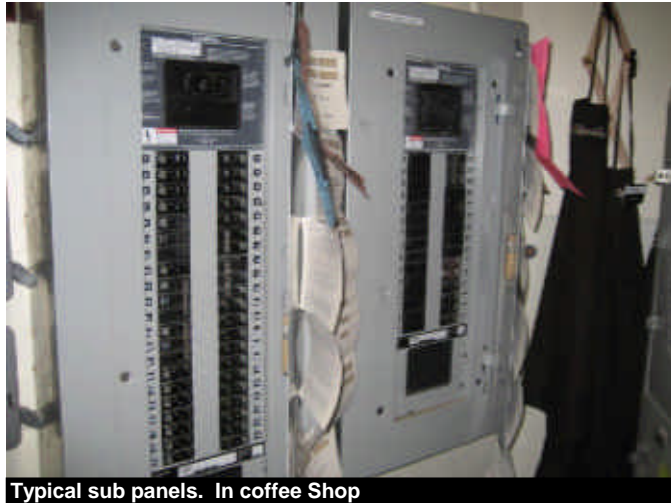
SUBPANEL LOCATION: Each unit has at least one sub panel in it. Each is a 200 amp sub panel.

Serviceable.

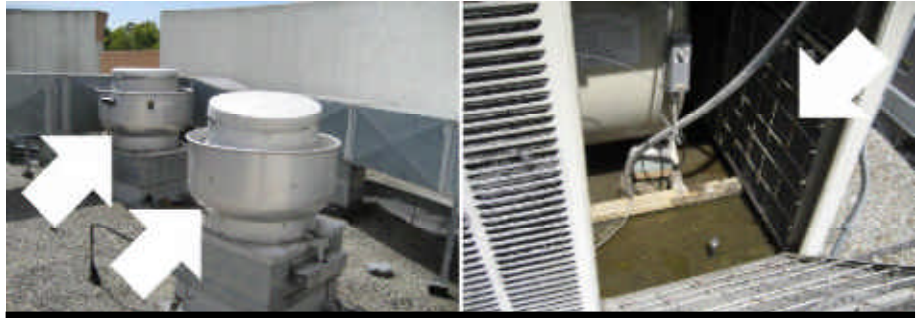
Abandoned equipment

There is some abandoned equipment on the roof of the left building. This appears to be over what used to be a restaurant as disclosed by the current tenant.

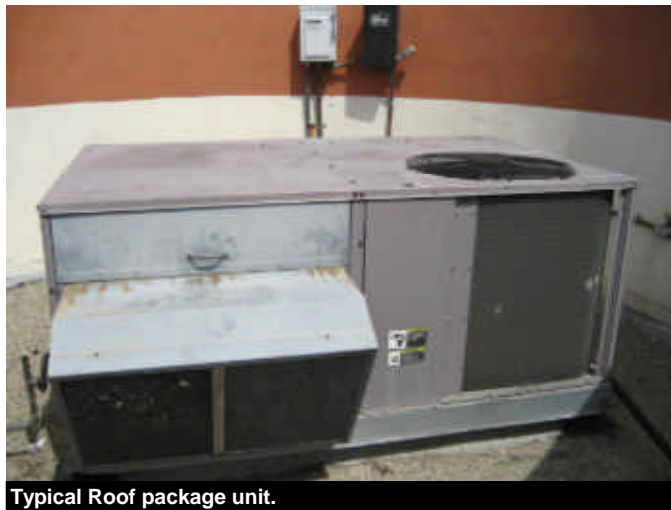
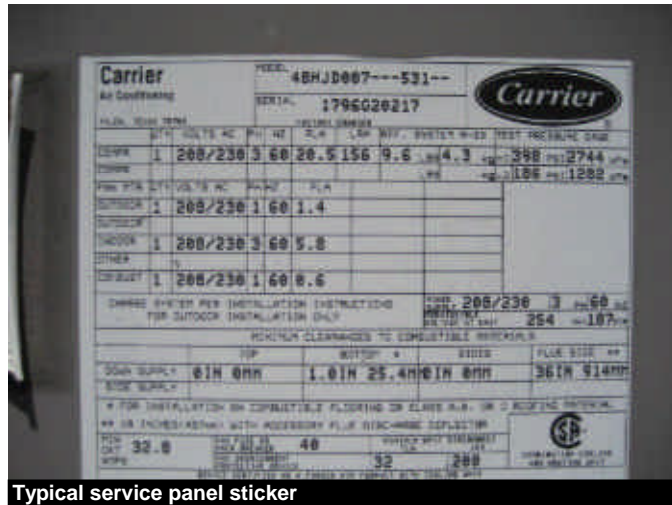
Typical service panel sticker

Each unit is a Carrier roof package type unit.

Each appears to be a 4 "ton" unit installed in either 1996 or 1997. This means that all units are approx. 10 years old.

The generally expected life for this type of unit is approx. 15-17 years. This means that all units are approx. 2/3's through their expected useful life. By industry standards within the next 5 years service will be needed on an increasing basis and expect some of the units to need some major work.

Proper maintenance for these units is to have them serviced at least once per year and ideally twice. A complete service and filter change is typically \$100 - \$200 per unit depending on the degree of service and the number of units serviced at one time in one location. If done individually expect approx. \$150 per year per unit for routine maintenance.
